Ellon Asset Condition Assessment

Final Report

16 April 2018

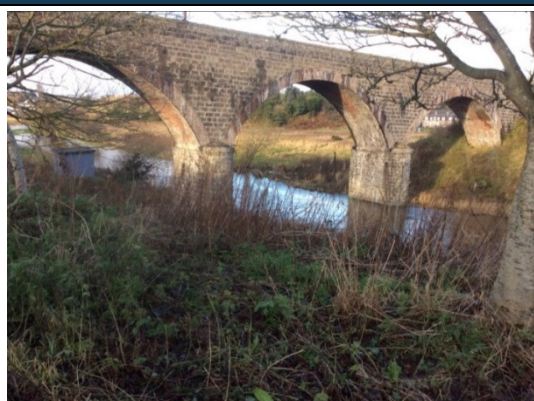
2- Meiklemill Railway Bridge (Refer to Figure 2-2)

View of bridge from downstream

Type: Four-arched bridge
Upstream grid ref: NJ 94713 30323
Span (m): Unknown
Material: Masonry
Condition: Grade 3 (Fair)
Part of FPS: No
Comments:
 No sign of deformation of arches.
 Minor mortar loss.
 Rust in arch soffits.
 Erosion of right bank.
Risk of Blockage: Low
Maintenance: None Required
Quick Win: N/A

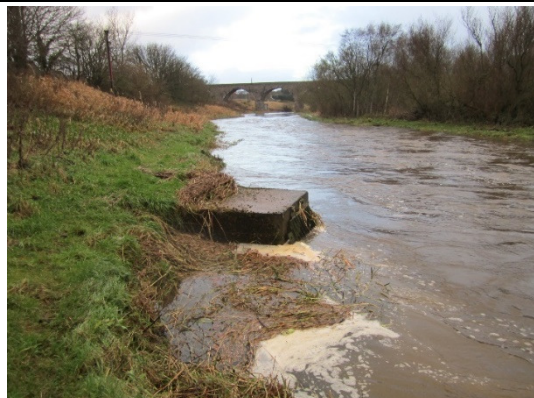
3- Meiklemill Culvert Outlet (Refer to Figure 2-2)

View from downstream

Type: Outfall
Upstream grid ref: NJ 94909 30240
Width (m): Unknown
Material: Concrete
Condition: Grade 3 (Fair)
Part of FPS: Yes
Comments:
 Trash screen connection to culvert compromised by loss of fixings.
 Minor bank erosion downstream.
Risk of Blockage: Moderate
Maintenance: Keep free of debris
Quick Win: Remove trash screen

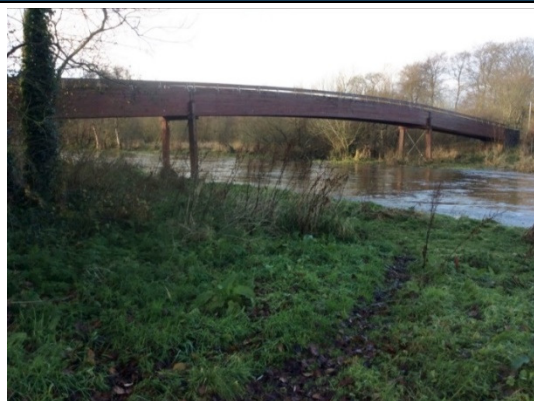
4- Meikle Mill Footbridge (Refer to Figure 2-2)

View of bridge from downstream

Type: Glulam timber bridge
Upstream grid ref: NJ 95076 30270
Span (m): 55
Material: Timber beam and deck
Condition: Grade 2 (Good)
Part of FPS: No
Comments:
 Signs of minor deterioration.
 Erosion at both banks.
Risk of Blockage: Low
Maintenance: None Required
Quick Win: N/A

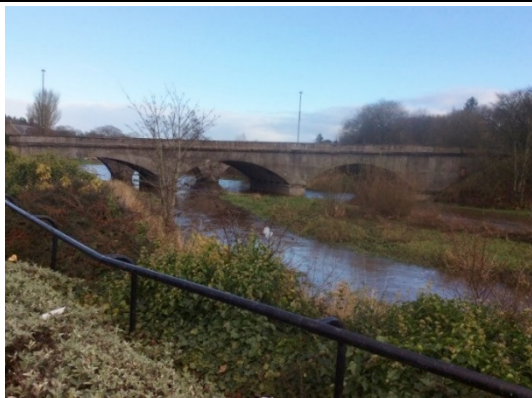
5- Ellon Bridge A920 (Refer to Figure 2-3)

View of bridge from upstream

Type: Three-arched vehicular bridge
Upstream grid ref: NJ 95681 30315
Span (m): 54.6
Material: Reinforced concrete
Condition: Grade 2 (Good)
Part of FPS: No
Comments:
 Minor cracks.
 Slight sealant loss.
 No sign of deformation of arches.
 Abutments well founded.
 Minor erosion of banks.
 Potentially at high risk of scour.
Risk of Blockage: Low
Maintenance: None Required
Quick Win: N/A

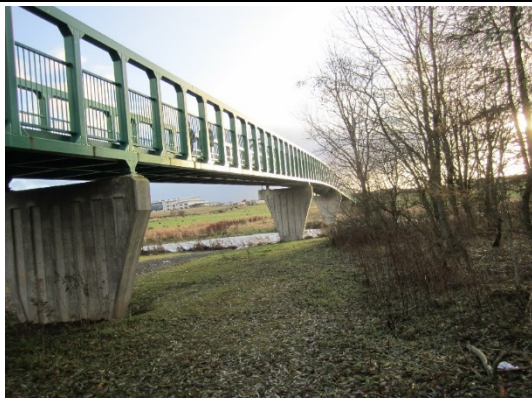
7- Boatie Tam's Brig (Refer to Figure 2-4)

View of bridge from upstream

Type: Pedestrian bridge
Upstream grid ref: NJ 96666 30364
Span (m): 127.5
Material: Steel beam / metal deck / concrete abutments
Condition: Grade 2 (Good)
Part of FPS: No
Comments:
 Minor cracks on abutments.
 No sign of deformation of beams.
 Localised surface corrosion.
Risk of Blockage: Low
Maintenance: None Required
Quick Win: N/A

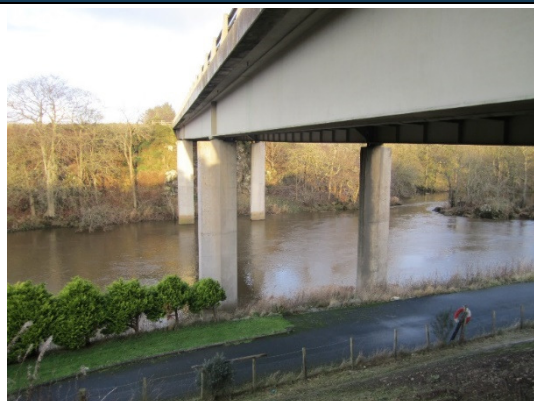
8- River Ythan Bridge A90 (Refer to Figure 2-5)

View of bridge from upstream

Type: Vehicular bridge
Upstream grid ref: NJ 97460 30304
Span (m): Unknown
Material: Steel beam / concrete columns
Condition: Grade 2 (Good)
Part of FPS: No
Comments:
 No sign of deformation of beams. Minor rust.
Risk of Blockage: Low
Maintenance: None Required
Quick Win: N/A

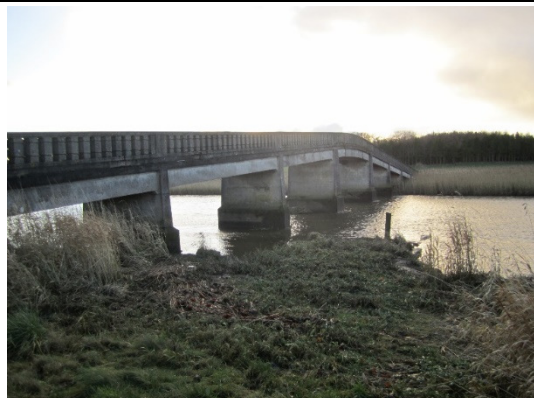
9- Logie Buchan Memorial Bridge (Refer to Figure 2-6)

View of bridge from upstream

Type: Nine-span pedestrian bridge
Upstream grid ref: NJ 99078 29927
Span (m): Unknown
Material: Reinforced concrete beam and slab
Condition: Grade 2 (Good)
Part of FPS: No
Comments:
 Minor cracks and spalling of slab and beam.
 Minor cracks of piers.
 Erosion of left bank.
Risk of Blockage: Low
Maintenance: None Required
Quick Win: N/A

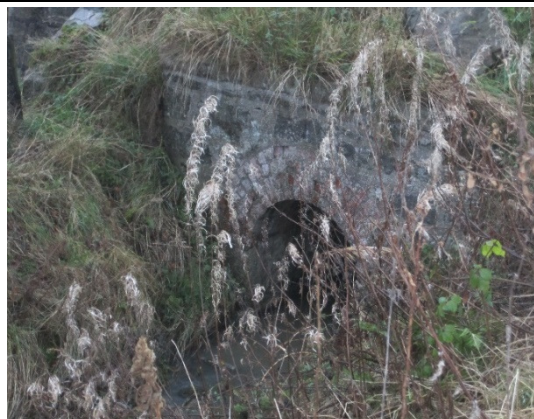
10 - Simple culvert (Refer to Figure 3-1)

View from downstream of culvert

Type: Simple culvert
Upstream grid ref: NJ 94676 31743
Width (m): Unknown
Length (m): 2.5 approx.
Material: Masonry
Condition: Grade 2 (Good)
Part of FPS: No
Comments:
 Culvert at side, masonry arch brick.
 Steep bank.
 Heavily vegetated channel.
Risk of Blockage: Moderate
Maintenance: Keep free of debris, keep vegetation growth under control.
Quick Win: N/A

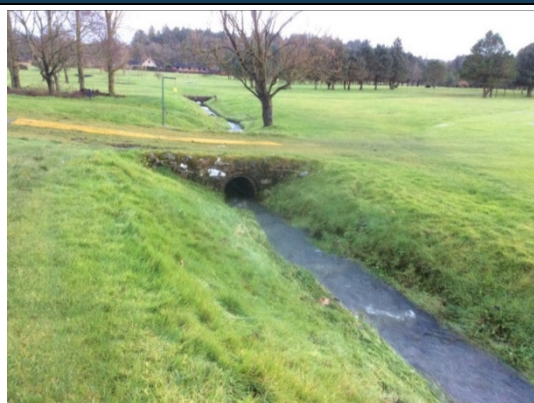
11 - Culvert (Refer to Figure 3-1)

View from upstream of culvert

Type: Simple culvert
Upstream grid ref: NJ 94956 31506
Material: Stone
Condition: Grade 2 (Good)
Part of FPS: No
Comments:
 Simple culvert at golf course.
 Minor erosion at bank sides.
 No signs of sediment deposition.
Risk of Blockage: Moderate
Maintenance: Keep free of debris
Quick Win: N/A

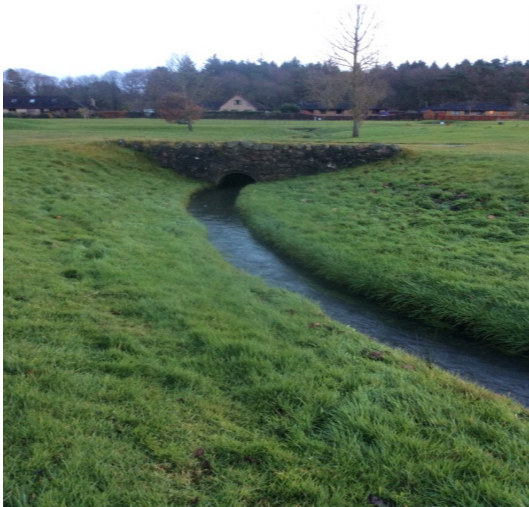
14 - Culvert (Refer to Figure 3-1)

View from upstream of culvert

Type: Simple culvert
Upstream grid ref: NJ 95071 31439
Material: Stone
Condition: Grade 2 (Good)
Part of FPS: No
Comments: None
Risk of Blockage: Moderate
Maintenance: Keep free of debris
Quick Win: N/A

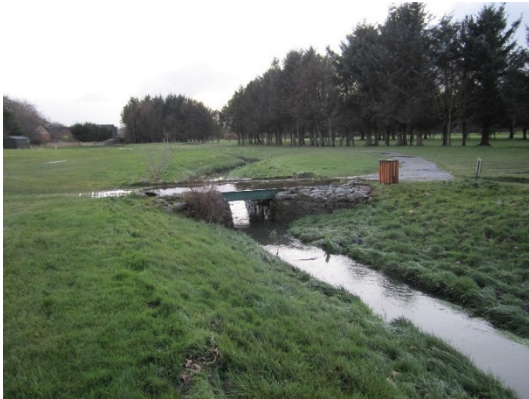
16 - Steel footbridge (Refer to Figure 3-1)

View from downstream of footbridge

Type: Bridge
Upstream grid ref: NJ 95121 31370
Material: Steel / stone
Condition: Grade 3 (Fair)
Part of FPS: No
Comments:
 Steel / concrete deck.
 Open-jointed stone abutment.
 Erosion of left bank.
 Bridge deck flooded.
Risk of Blockage: Moderate
Maintenance: Keep free of debris
Quick Win: N/A

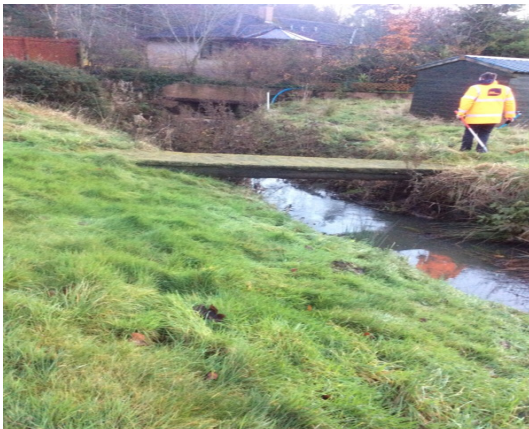
17 - Timber footbridge (Refer to Figure 3-1)

View from upstream of footbridge

Type: Timber footbridge
Upstream grid ref: NJ 95110 31307
Material: Timber
Width (m): 1 approx.
Condition: Grade 5 (Very Poor)
Part of FPS: No
Comments:
 Timber slippery and showing signs of rot.
 Supports showing signs of settlement.
 Small amounts of sediment deposited.
Risk of Blockage: Moderate
Maintenance: Keep free of debris
Quick Win: N/A

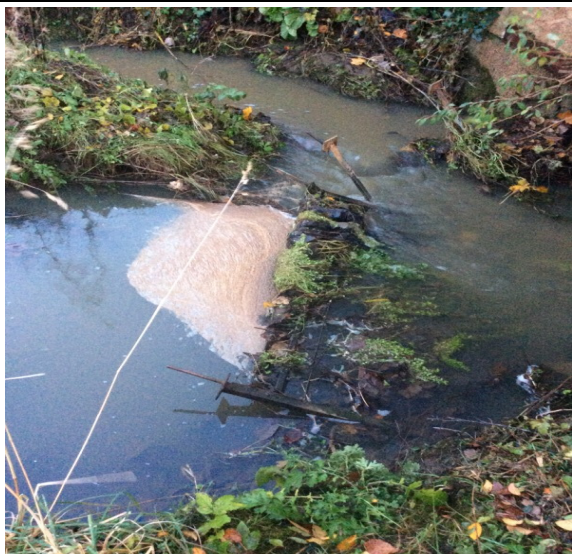
Type: Simple culvert
Upstream grid ref: NJ 95115 31300
Material: Concrete
Length (m): 245 approx.
Condition: Grade 3 (Fair)
Part of FPS: Yes
Comments:
 Significant amount of undercutting along left and right bank.
 Ivy on left hand side.
 Sediment deposition.
 Trash screen detached.
 Brickwork element.
 Open masonry joints.
 Minor cracks.
 Service pipe inside culvert.
Risk of Blockage: High
Maintenance: Keep watercourse free of debris
Quick Win: Remove debris, remove detached trash screen

Trash screen and debris in river

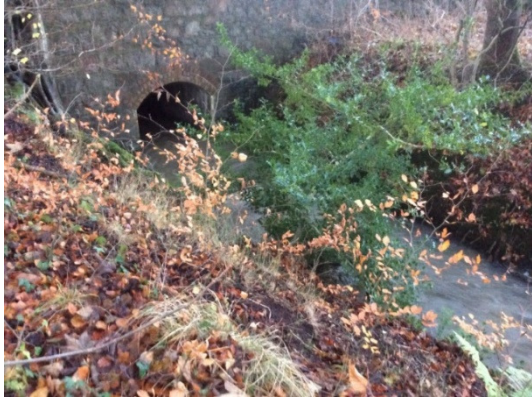
20 – Culvert (Refer to Figure 3-2)

<p>Type: Simple culvert Upstream grid ref: NJ 95056 30922 Height (m): 1.5 Width (m): 1.825 Length (m): 3 approx. Material: Masonry Condition: Grade 2 (Good) Part of FPS: Yes Comments: Minor settlement of culvert. No vegetation through culvert walls. Minor mortar loss. Steep and slightly eroded banks at upstream side of culvert. Tree supporting right bank at upstream side of culvert. Steep and unvegetated right bank at downstream side of culvert. Severe erosion of left hand bank downstream. Risk of Blockage: Low Maintenance: Keep free of debris Quick Win: N/A</p>

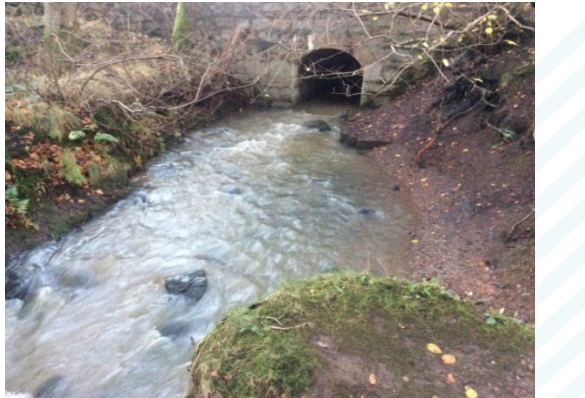
<p><i>Upstream view of watercourse</i></p>	<p><i>View from downstream of culvert showing eroded banks (outlet)</i></p>

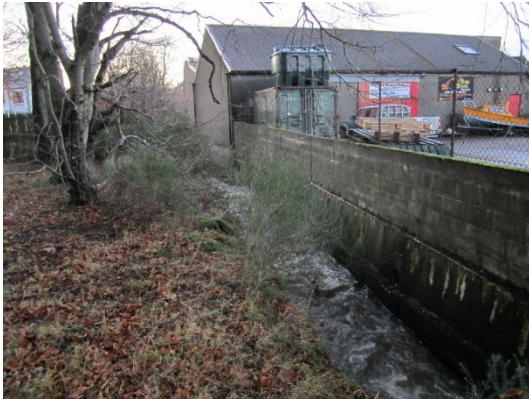
21 - Retaining wall (Refer to Figure 3-2)

Upstream view of wall

Type: Retaining wall
Upstream grid ref: NJ 95052 30762
Height (m): 1.5
Length (m): 19 approx.
Material: Concrete
Condition: Grade 3 (Fair)
Part of FPS: Yes
Comments:
 Minor cracking.
 Sealant seepage through joints.
 Minor vegetation growth.
 Outfall next to wall at upstream.
Risk of Blockage: Low
Maintenance: None required
Quick Win: N/A

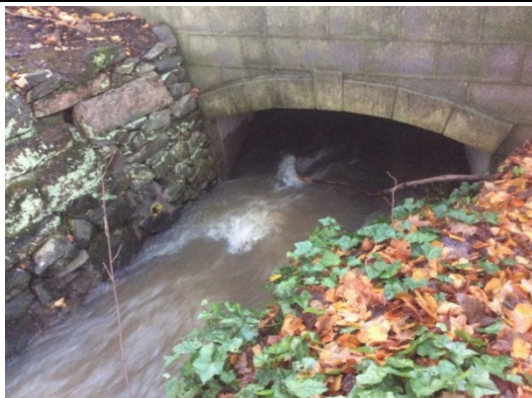
22 - Station Road Culvert B9005 (Refer to Figure 3-2)

Upstream view of culvert

Type: Simple culvert
Upstream grid ref: NJ 95060 30627
Width (m): 2.185
Length (m): 3 approx.
Material: Masonry
Condition: Grade 2 (Good)
Part of FPS: Yes
Comments:
 No sign of movement.
 Open joints in masonry wall upstream.
 Overgrown and undercut banks downstream.
Risk of Blockage: Low
Maintenance: None required
Quick Win: N/A

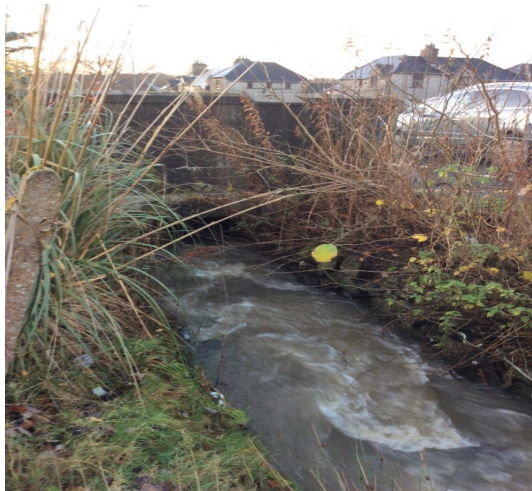
23 - Modley Burn Bridge (Refer to Figure 3-3)

Upstream view of culvert

Type: Simple arch culvert
Upstream grid ref: NJ 95074 30565
Span (m): 3.5
Length (m): 7.3
Width (between walls) (m): 5.335
Material: Reinforced concrete
Condition: Grade 3 (Fair)
Part of FPS: Yes
Comments:
 Cracking in render.
 Sealant loss.
 Seepage through joints.
 Minor crest lowering.
 Eroded and overgrown banks.
Risk of Blockage: Moderate
Maintenance: Keep free of debris
Quick Win: N/A

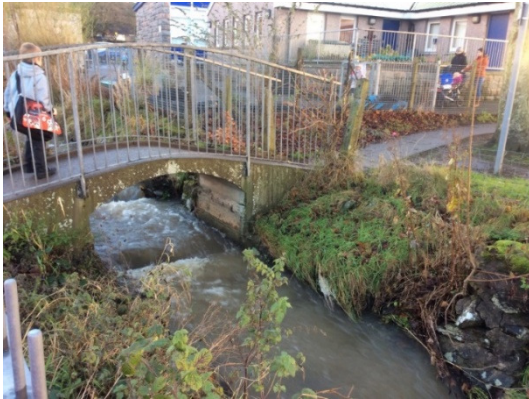
24- Ellon Primary School footbridge (Refer to Figure 3-3)

Downstream view of footbridge

Type: Arch footbridge
Upstream grid ref: NJ 95071 30520
Material: Concrete deck and abutments / steel parapet
Length (m): 1 approx.
Condition: Grade 2 (Good)
Part of FPS: Yes
Comments:
 Minor cracks at abutments.
 No deformation to arch.
 Superficial defects.
 Eroded banks upstream and downstream.
 Weir effect over invert.
Risk of Blockage: Moderate
Maintenance: Keep channel free of debris
Quick Win: N/A

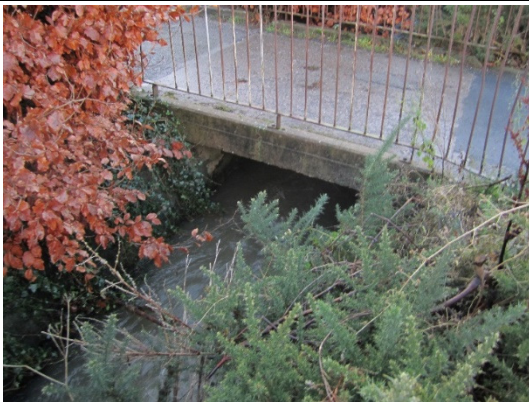
25- Footbridge (Refer to Figure 3-3)

Upstream view of footbridge

Type: Single-span footbridge
Upstream grid ref: NJ 95078 30453
Length (m): 2.8
Material: Concrete / steel parapet
Condition: Grade 2 (Good)
Part of FPS: No
Comments:
 Minor cracks in deck.
 Severe corrosion of handrails.
 Deformation of rails.
 Pipe directly downstream of the bridge.
 Heavily vegetated banks upstream and downstream.
Risk of Blockage: Moderate
Maintenance: Remove any debris and control vegetation growth
Quick Win: N/A

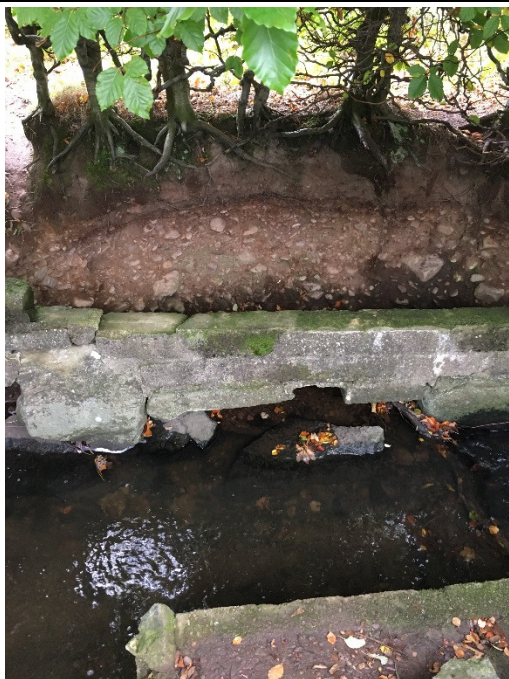
26- Masonry Wall (Refer to Figure 3-3)

Downstream view

Type: Masonry Wall
Upstream grid ref: NJ 95074 30452
Material: Masonry
Condition: Grade 5 (Very Poor)
Part of FPS: No
Comments:
 Major masonry loss.
 Loss of backfill / ground behind the wall.
Risk of Blockage: Low
Maintenance: Maintain channel free of debris
Quick Win: N/A

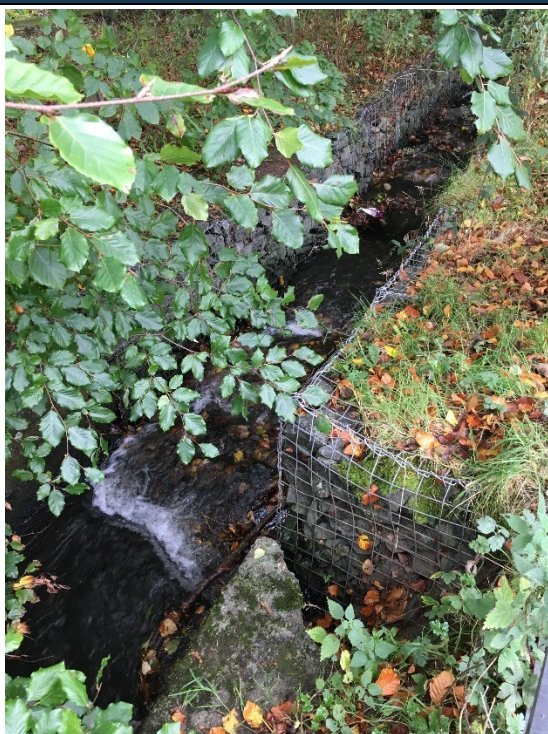
27- Gabion Baskets (Refer to Figure 3-3)

Upstream view

Type: Gabions
Upstream grid ref: NJ 95074 30452
Material: Masonry
Condition: Grade 2 (Good)
Part of FPS: No
Comments:
 Some distortion of alignment.
 Minor evidence of sliding.
 Packed below maximum capacity.
 Poor maintenance access.
Risk of Blockage: Low
Maintenance: Maintain channel free of debris
Quick Win: N/A

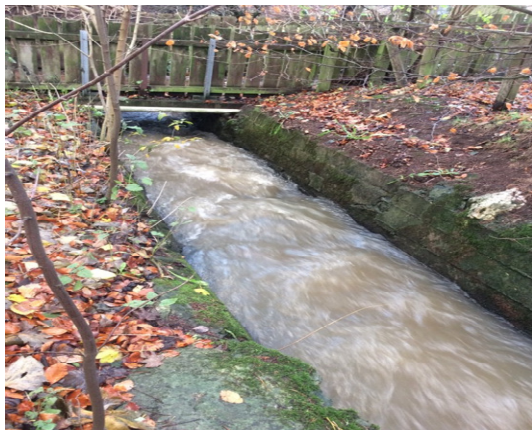
28- Gordon Park footbridge (Refer to Figure 3-3)

View from upstream

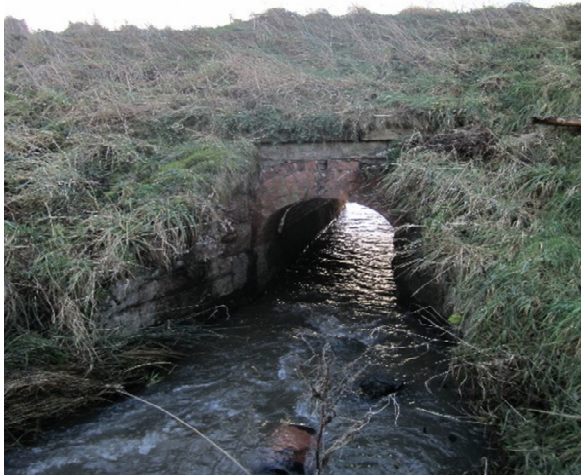
32- Masonry culvert (Refer to Figure 4-2)

Upstream view of culvert

Type: Masonry culvert and headwall
Upstream grid ref: NJ 96531 31663
Span (m): Unknown
Material: Masonry
Length (m): 12
Condition: Grade 2 (Good)
Part of FPS: No
Comments:
 Minor loss of mortar and spalling of arch and headwalls.
 High risk of scour (according to Aberdeenshire Council's notes).
Risk of Blockage: Low
Maintenance: Keep free of debris
Quick Win: N/A

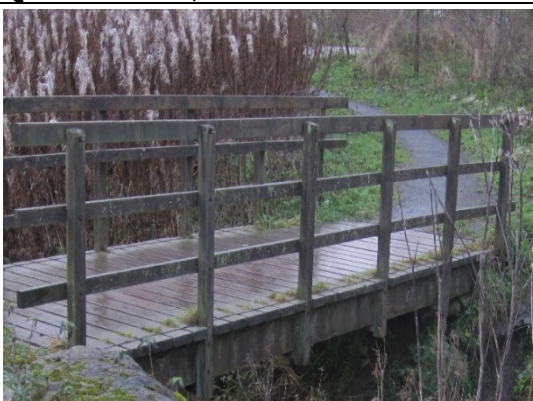
<p>Downstream view of bridge, loose fixings</p>

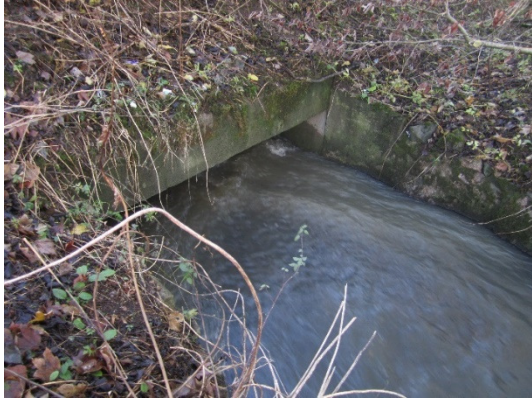
37- Culvert A920 (Refer to Figure 4-3)

<p><i>Upstream view of culvert</i></p>	<p>Type: Simple culvert, hollow concrete slab</p> <p>Upstream grid ref: NJ 96955 30653</p> <p>Inlet span (m): 3.1</p> <p>Outlet span (m): 2.8</p> <p>Rise (m): 0.6</p> <p>Length (m): 33</p> <p>Material: Reinforced concrete slab and abutment</p> <p>Condition: Grade 2 (Good)</p> <p>Part of FPS: No</p> <p>Comments: Minor settlement of soffit. Minor vegetation growth on soffit. Concrete outlet structure directly upstream.</p> <p>Risk of Blockage: High</p> <p>Maintenance: Keep culvert and trash screen free of debris</p> <p>Quick Win: Remove excess vegetation, remove trash screen</p>

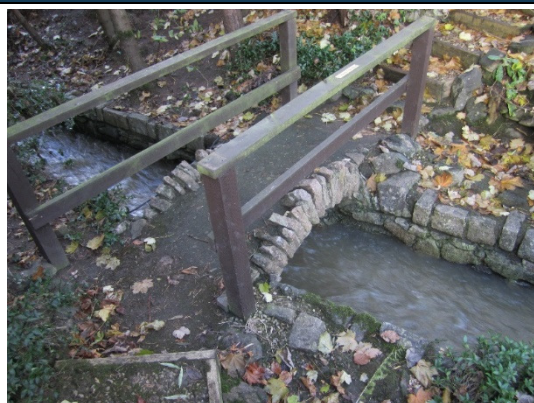
38- Footbridge (Refer to Figure 4-4)

View of bridge

Type: Footbridge
Upstream grid ref: NJ 97085 30578
Width (m): 3.6
Material: Timber / masonry
Condition: Grade 2 (Good)
Part of FPS: No
Comments:
 Superficial defects on handrails.
 Steps in channel downstream.
 Watercourse channelized upstream and downstream.
Risk of Blockage: Low
Maintenance: None required
Quick Win: N/A

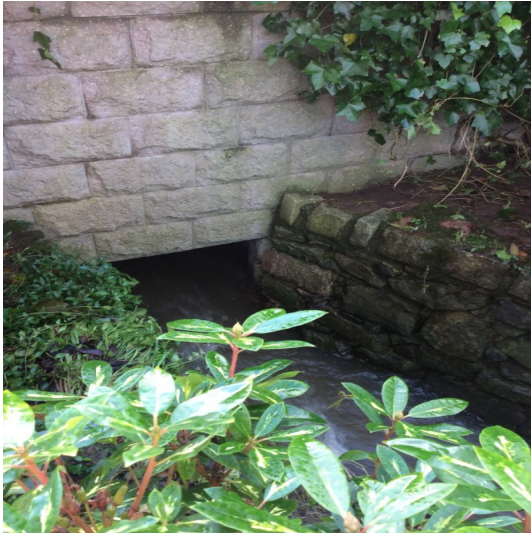
39- Culvert (Refer to Figure 4-4)

<p><i>Upstream view of culvert</i></p>	<p>Type: Simple culvert Upstream grid ref: NJ 97099 30561 Width (m): 1 Material: Masonry Condition: Grade 1 (Very Good) Part of FPS: No Comments: No cracks. No distortion of shape. Risk of Blockage: Moderate Maintenance: Keep free of debris Quick Win: N/A</p>
40- Footbridge (Refer to Figure 4-4)

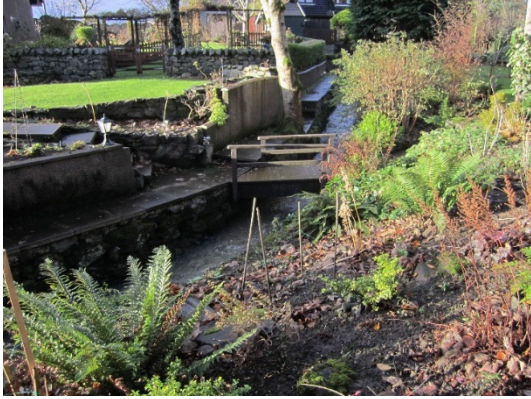
<p><i>Downstream view of bridge</i></p>	<p>Type: Single-span footbridge Upstream grid ref: NJ 97127 30536 Material: Timber Condition: Grade 1 (Very Good) Part of FPS: No Comments: No visible defects. No signs of deterioration of timber or fixings. Bridge ties into wall. Risk of Blockage: Low Maintenance: None required Quick Win: N/A</p>

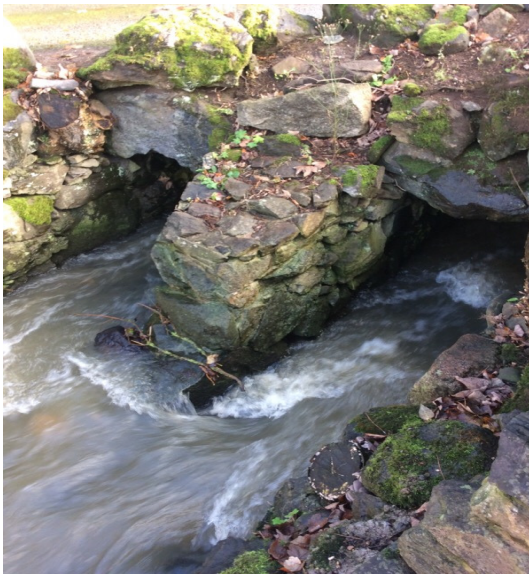
41- Culvert (Refer to Figure 4-4)

Upstream view of culvert

Type: Twin-bore stone culvert
Upstream grid ref: NJ 97135 30527
Material: Timber
Condition: Grade 3 (Fair)
Part of FPS: No
Comments:
 Loose stonework over top of culvert.
 Minor vegetation growth.
 Displaced stonework.
Risk of Blockage: High
Maintenance: Keep free of debris
Quick Win: N/A

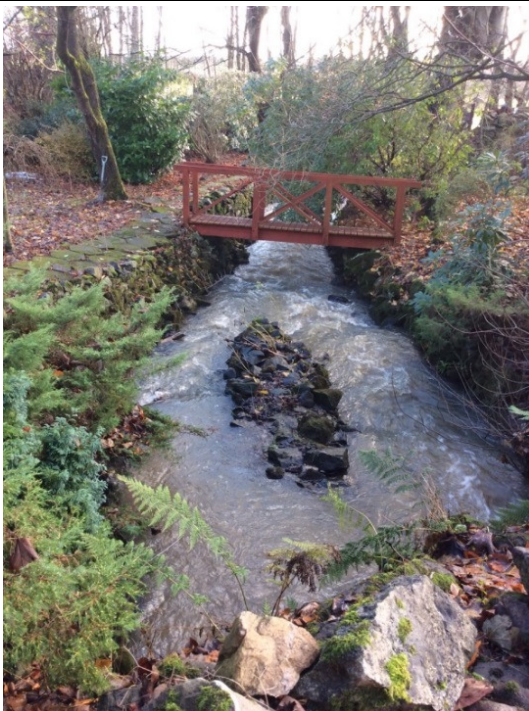
42- Footbridge (Refer to Figure 4-4)

Upstream view of footbridge

Type: Single-span footbridge
Upstream grid ref: NJ 97134 30523
Material: Timber
Condition: Grade 1 (Very Good)
Part of FPS: No
Comments:
 No visible defects.
 No signs of deterioration of timber or fixings.
Risk of Blockage: Moderate
Maintenance: Keep free of debris
Quick Win: N/A

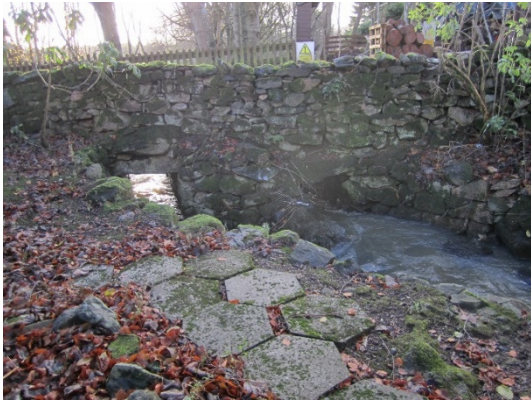
43- Culvert (Refer to Figure 4-4)

<p><i>Upstream view of culvert</i></p>	<p>Type: Twin-bore stone culvert Upstream grid ref: NJ 97148 30505 Material: Stone Condition: Grade 4 (Poor) Part of FPS: No Comments: Possible deformation of shape. Possible displacement of stonework at downstream end. Risk of Blockage: High Maintenance: Keep free of debris Quick Win: N/A</p>

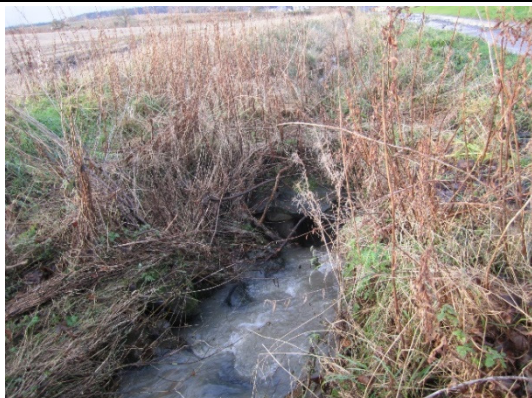
45- Stone culvert (Refer to Figure 5-1)

View from downstream of culvert

Type: Simple culvert
Upstream grid ref: NJ 94802 29695
Width (m): Unknown
Material: Stone
Condition: Grade 3 (Fair)
Part of FPS: No
Comments: Vegetation blocking part of culvert. Distortion of cross section.
Risk of Blockage: High
Maintenance: Keep vegetation growth under control
Quick Win: N/A

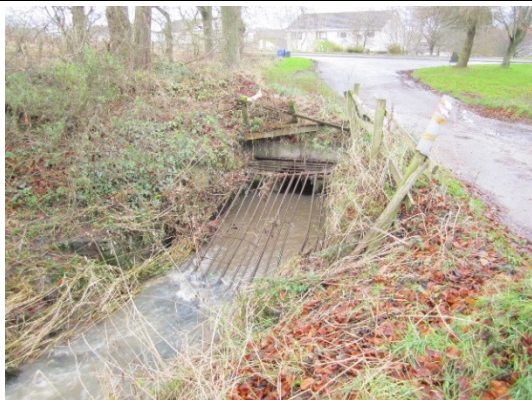
46- Meiklemill culvert (Refer to Figure 5-1)

Upstream view of culvert (inlet)

Type: Semi-circular simple culvert
Upstream grid ref: NJ 94731 29809
Width (m): 1.5 (approximately)
Diameter (m): 0.75 (approximately)
Material: Concrete
Condition: Grade 4 (Poor)
Part of FPS: No
Comments: Minor cracks and spalling. Minor settlement. Rust staining. High and stiff vegetation at both sides of bank. Distortion of trash screen's bars.

Timber protective fence partially collapsed.
Risk of Blockage: High
Maintenance: Keep vegetation growth under control
Quick Win: Replace trash screen

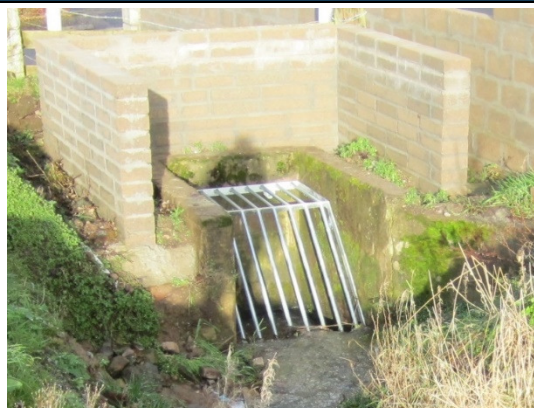
47- Hillhead Drive culvert (Refer to Figure 6-1)

Culvert upstream (inlet with trash screen)

Type: Culvert headwall and screen
Upstream grid ref: NJ 95343 29732
Headwall Height (m): 2.1
Headwall Width (m): 2.31
Material: Concrete / masonry
Condition: Grade 3 (Fair)
Part of FPS: Yes
Comments:
 Vertical cracks at corners of old headwall.
 Minor vegetation growth on concrete headwalls.
 Loss of mortar at masonry headwall.
 Moderately steep and eroded banks.
 High flows bypass the culvert.
 Poor access to clean trash screen.
 Not tied in to surrounding ground.
Risk of Blockage: Moderate
Maintenance: Keep trash screens free of debris
Quick Win: Tie in head wall to surrounding ground
