Ellon Asset Condition Assessment

Final Report

16 April 2018

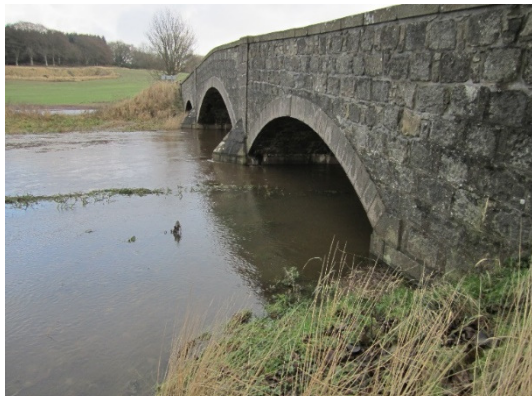
1- Bridge of Ardlethen B9005 (Refer to Figure 2-1)

View from upstream

Type: Three-arched vehicular bridge
Upstream grid ref: NJ 92489 30834
Span (m): 36.9
Material: Masonry
Condition: Grade 2 (Good)
Part of FPS: No
Comments:
 Minor cracks.
 Some loss of mortar.
 No sign of deformation of arches.
 Potentially high risk of scour.
Risk of Blockage: Low
Maintenance: None Required
Quick Win: N/A

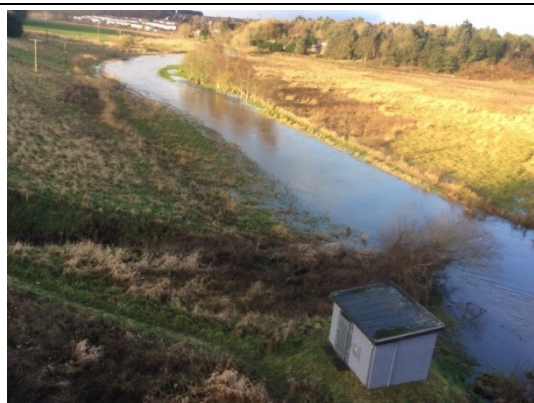
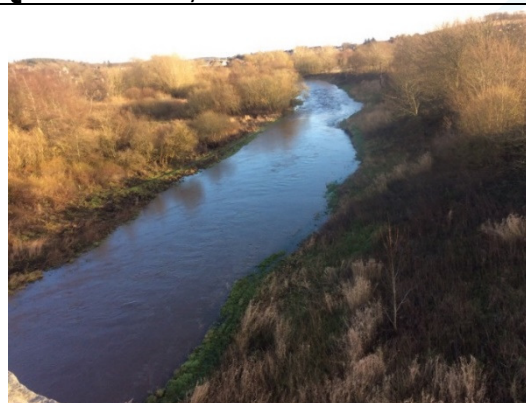
2- Meiklemill Railway Bridge (Refer to Figure 2-2)

Type: Four-arched bridge
Upstream grid ref: NJ 94713 30323
Span (m): Unknown
Material: Masonry
Condition: Grade 3 (Fair)
Part of FPS: No
Comments:
 No sign of deformation of arches.
 Minor mortar loss.
 Rust in arch soffits.
 Erosion of right bank.
Risk of Blockage: Low
Maintenance: None Required
Quick Win: N/A

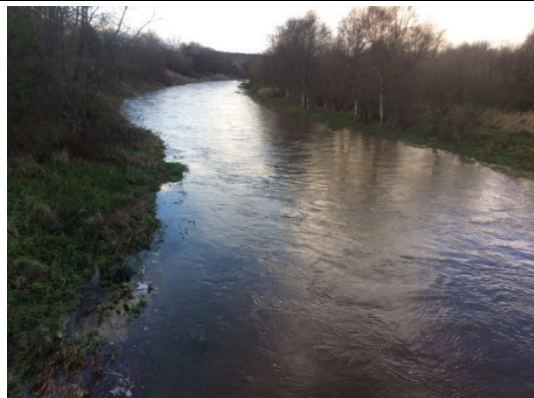
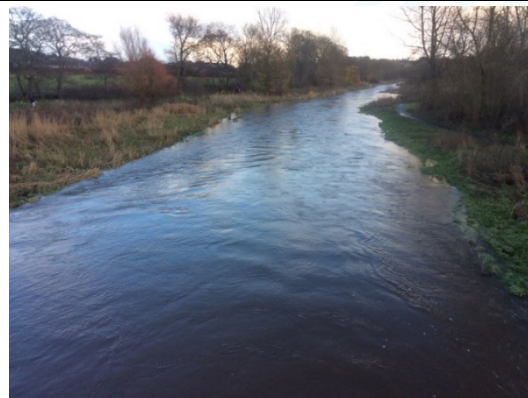
4- Meikle Mill Footbridge (Refer to Figure 2-2)

Type: Glulam timber bridge
Upstream grid ref: NJ 95076 30270
Span (m): 55
Material: Timber beam and deck
Condition: Grade 2 (Good)
Part of FPS: No
Comments:
 Signs of minor deterioration.
 Erosion at both banks.
Risk of Blockage: Low
Maintenance: None Required
Quick Win: N/A

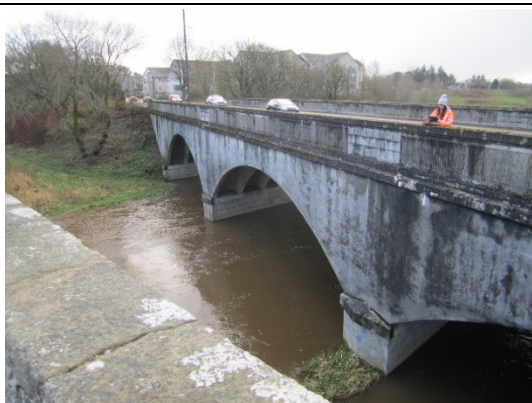
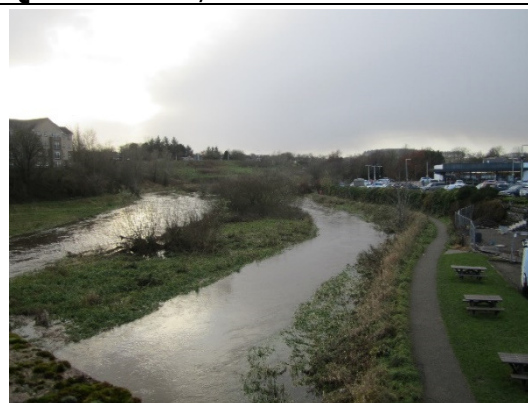
5- Ellon Bridge A920 (Refer to Figure 2-3)

Type: Three-arched vehicular bridge
Upstream grid ref: NJ 95681 30315
Span (m): 54.6
Material: Reinforced concrete
Condition: Grade 2 (Good)
Part of FPS: No
Comments:
 Minor cracks.
 Slight sealant loss.
 No sign of deformation of arches.
 Abutments well founded.
 Minor erosion of banks.
 Potentially at high risk of scour.
Risk of Blockage: Low
Maintenance: None Required
Quick Win: N/A

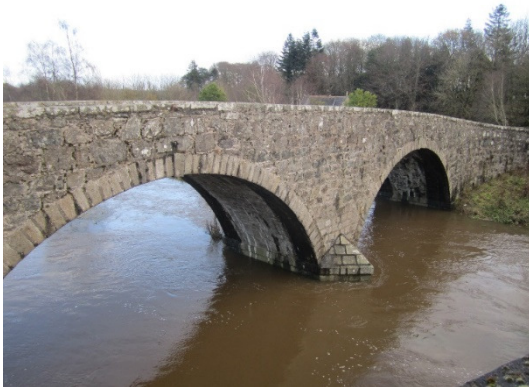
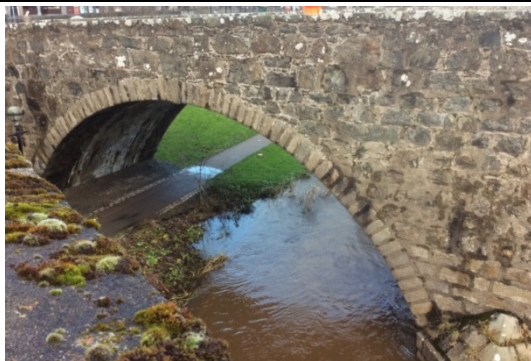
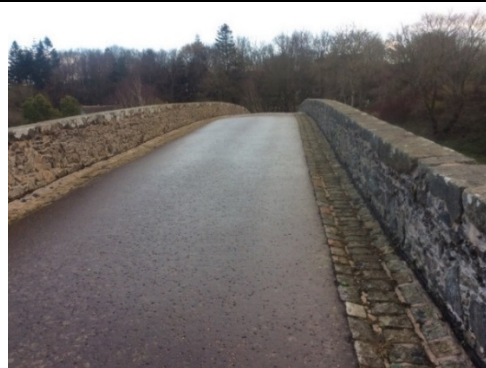
6- Old Bridge of Ellon (Refer to Figure 2-3)

Upstream view of bridge

Type: Three-arched bridge
Upstream grid ref: NJ 95685 30334
Span (m): 45.8
Material: Masonry
Condition: Grade 3 (Fair)
Part of FPS: No
Comments:
 Lengthy cracks.
 Loss of mortar.
 Water stains.
 Bridge not open to vehicles.
 Increased potential flood risk upstream due to close proximity of two structures.
 Potentially at high risk of scour.
Risk of Blockage: Low
Maintenance: None Required
Quick Win: N/A

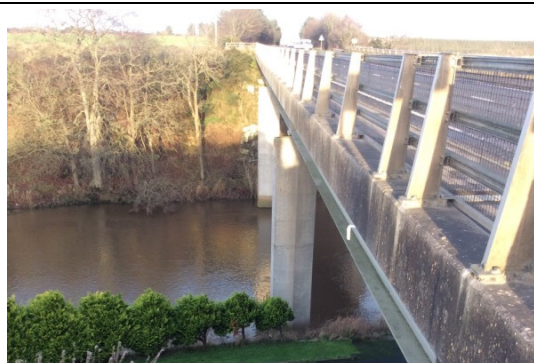
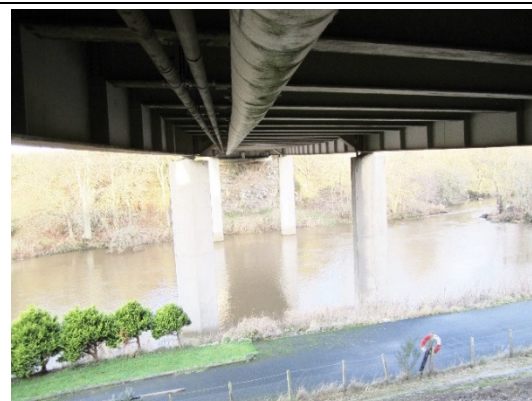
8- River Ythan Bridge A90 (Refer to Figure 2-5)

Type: Vehicular bridge
Upstream grid ref: NJ 97460 30304
Span (m): Unknown
Material: Steel beam / concrete columns
Condition: Grade 2 (Good)
Part of FPS: No
Comments:
 No sign of deformation of beams. Minor rust.
Risk of Blockage: Low
Maintenance: None Required
Quick Win: N/A

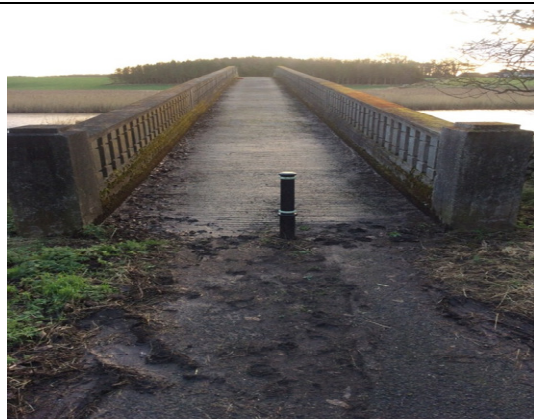
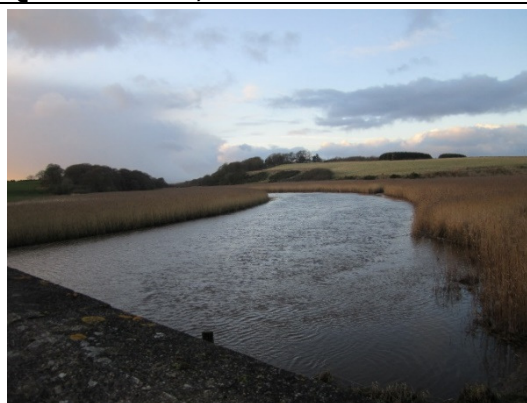
9- Logie Buchan Memorial Bridge (Refer to Figure 2-6)

Type: Nine-span pedestrian bridge
Upstream grid ref: NJ 99078 29927
Span (m): Unknown
Material: Reinforced concrete beam and slab
Condition: Grade 2 (Good)
Part of FPS: No
Comments:
 Minor cracks and spalling of slab and beam.
 Minor cracks of piers.
 Erosion of left bank.
Risk of Blockage: Low
Maintenance: None Required
Quick Win: N/A

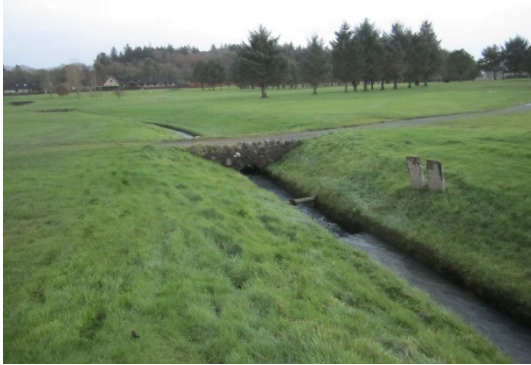
12 - Culvert (Refer to Figure 3-1)

<p><i>View from upstream of culvert</i></p>	<p>Type: Simple culvert Upstream grid ref: NJ 94977 31490 Material: Stone Condition: Grade 2 (Good) Part of FPS: No Comments: Pipe upstream of the culvert. Stable bank. Risk of Blockage: Moderate Maintenance: Keep free of debris Quick Win: N/A</p>

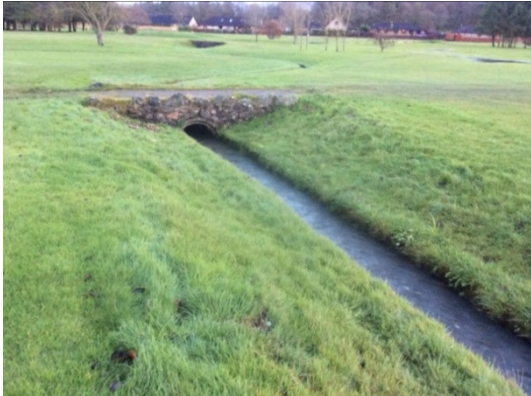
13 - Culvert (Refer to Figure 3-1)

<p><i>View from upstream of culvert</i></p>	<p>Type: Simple culvert Upstream grid ref: NJ 95018 31458 Material: Stone Condition: Grade 2 (Good) Part of FPS: No Comments: None Risk of Blockage: Moderate Maintenance: Keep free of debris Quick Win: N/A</p>

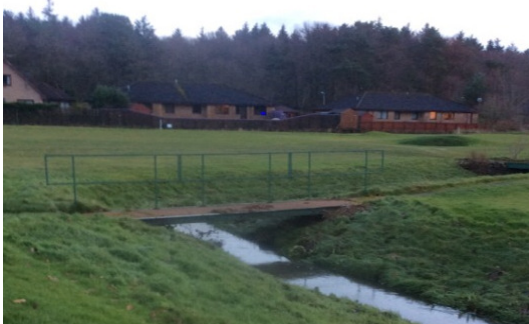
15 - Footbridge (Refer to Figure 3-1)

View from upstream of footbridge

Type: Single-span footbridge
Upstream grid ref: NJ 95112 31396
Width (m): 1 (approximately)
Material: Steel
Condition: Grade 2 (Good)
Part of FPS: No
Comments: Eroded left bank directly upstream of the bridge.
Risk of Blockage: Low
Maintenance: None required
Quick Win: N/A

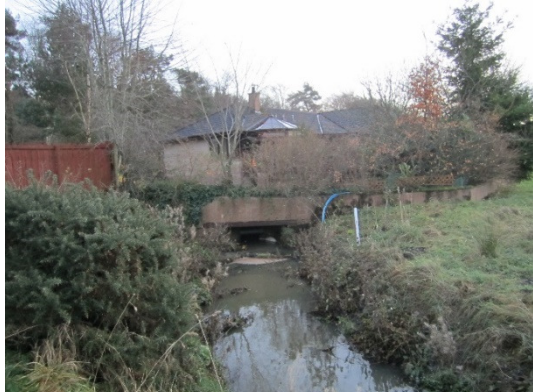
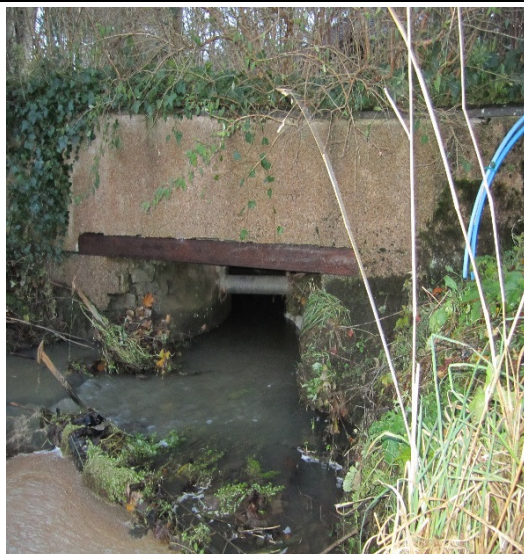
18 – Hospital Road Culvert Inlet (Refer to Figure 3-1)

View from upstream of culvert

Type: Simple culvert
Upstream grid ref: NJ 95115 31300
Material: Concrete
Length (m): 245 approx.
Condition: Grade 3 (Fair)
Part of FPS: Yes
Comments:
 Significant amount of undercutting along left and right bank.
 Ivy on left hand side.
 Sediment deposition.
 Trash screen detached.
 Brickwork element.
 Open masonry joints.
 Minor cracks.
 Service pipe inside culvert.
Risk of Blockage: High
Maintenance: Keep watercourse free of debris
Quick Win: Remove debris, remove detached trash screen

View from upstream of culvert. Service pipe inside culvert

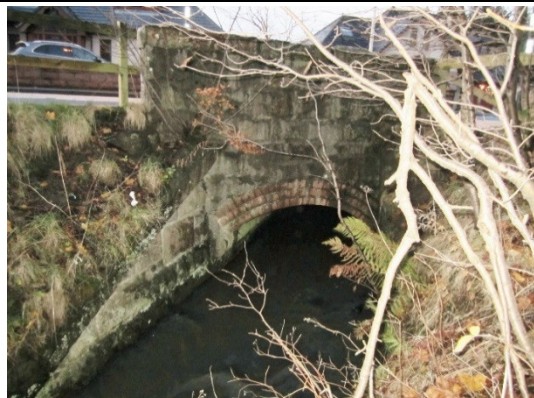
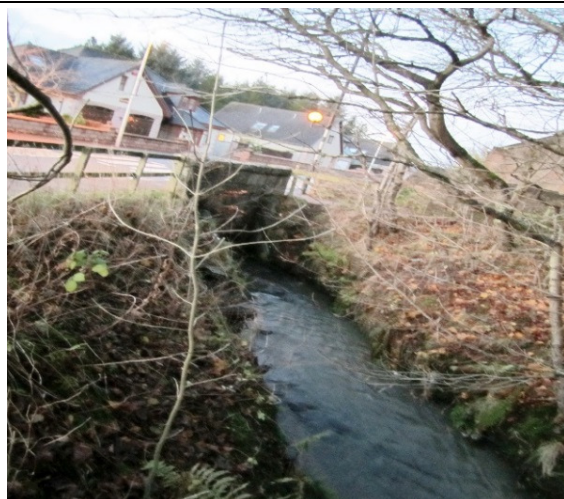
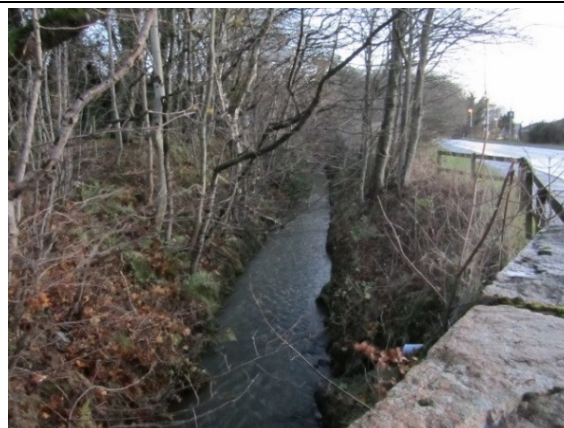
19 - Hospital Road Culvert Outlet (Refer to Figure 3-2)

View from downstream of culvert

Condition: Grade 3 (Fair)

Minor cracks.

Maintenance: Keep free of debris

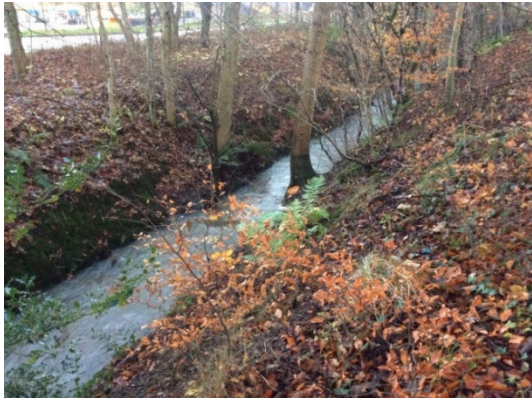
20 – Culvert (Refer to Figure 3-2)

<p>Type: Simple culvert Upstream grid ref: NJ 95056 30922 Height (m): 1.5 Width (m): 1.825 Length (m): 3 approx. Material: Masonry Condition: Grade 2 (Good) Part of FPS: Yes Comments: Minor settlement of culvert. No vegetation through culvert walls. Minor mortar loss. Steep and slightly eroded banks at upstream side of culvert. Tree supporting right bank at upstream side of culvert. Steep and unvegetated right bank at downstream side of culvert. Severe erosion of left hand bank downstream. Risk of Blockage: Low Maintenance: Keep free of debris Quick Win: N/A</p>

<p><i>Upstream view of watercourse</i></p>	<p><i>View from downstream of culvert showing eroded banks (outlet)</i></p>

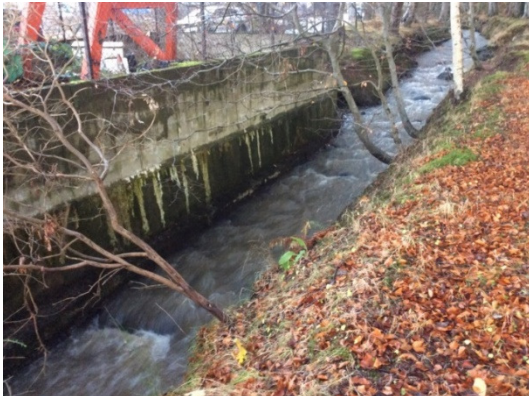
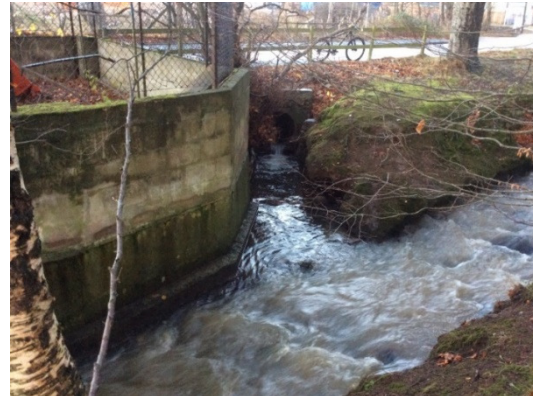
21 - Retaining wall (Refer to Figure 3-2)

Type: Retaining wall
Upstream grid ref: NJ 95052 30762
Height (m): 1.5
Length (m): 19 approx.
Material: Concrete
Condition: Grade 3 (Fair)
Part of FPS: Yes
Comments:
 Minor cracking.
 Sealant seepage through joints.
 Minor vegetation growth.
 Outfall next to wall at upstream.
Risk of Blockage: Low
Maintenance: None required
Quick Win: N/A

View from downstream of the wall showing water stains

Outfall next to the upstream side of the wall

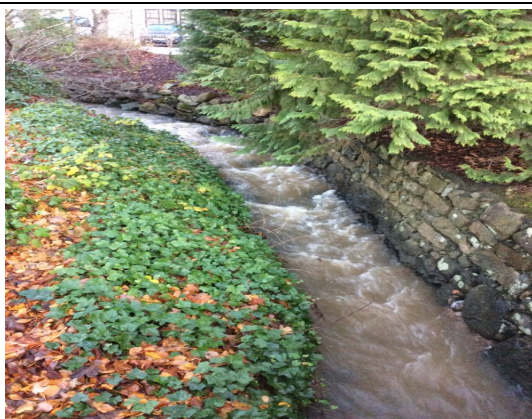
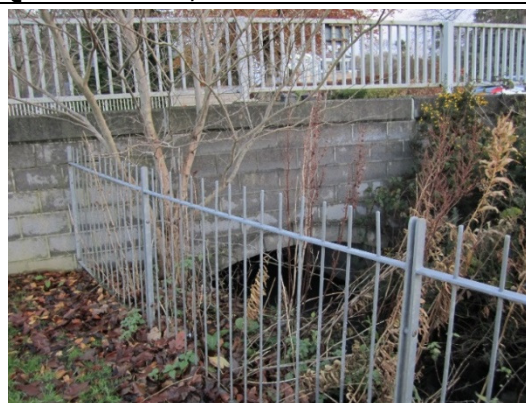
22 - Station Road Culvert B9005 (Refer to Figure 3-2)

Type: Simple culvert
Upstream grid ref: NJ 95060 30627
Width (m): 2.185
Length (m): 3 approx.
Material: Masonry
Condition: Grade 2 (Good)
Part of FPS: Yes
Comments:
 No sign of movement.
 Open joints in masonry wall upstream.
 Overgrown and undercut banks downstream.
Risk of Blockage: Low
Maintenance: None required
Quick Win: N/A

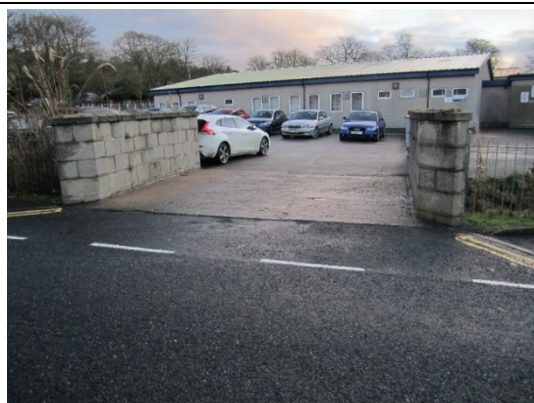
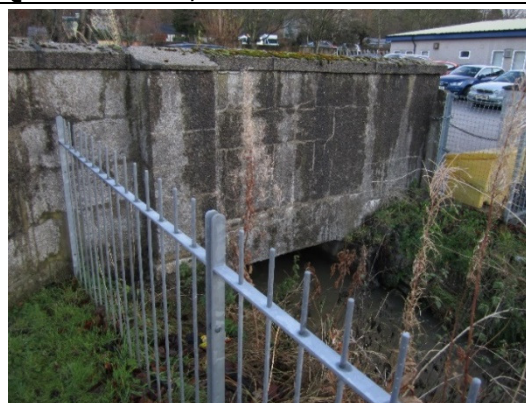
23 - Modley Burn Bridge (Refer to Figure 3-3)

Type: Simple arch culvert
Upstream grid ref: NJ 95074 30565
Span (m): 3.5
Length (m): 7.3
Width (between walls) (m): 5.335
Material: Reinforced concrete
Condition: Grade 3 (Fair)
Part of FPS: Yes
Comments:
 Cracking in render.
 Sealant loss.
 Seepage through joints.
 Minor crest lowering.
 Eroded and overgrown banks.
Risk of Blockage: Moderate
Maintenance: Keep free of debris
Quick Win: N/A

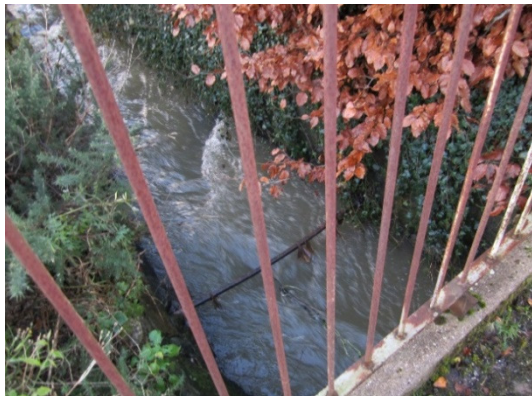
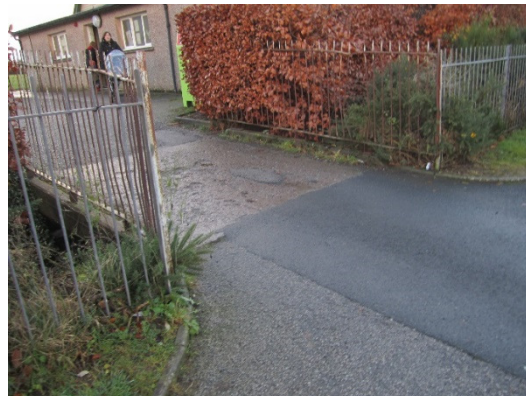
25- Footbridge (Refer to Figure 3-3)

Type: Single-span footbridge
Upstream grid ref: NJ 95078 30453
Length (m): 2.8
Material: Concrete / steel parapet
Condition: Grade 2 (Good)
Part of FPS: No
Comments:
 Minor cracks in deck.
 Severe corrosion of handrails.
 Deformation of rails.
 Pipe directly downstream of the bridge.
 Heavily vegetated banks upstream and downstream.
Risk of Blockage: Moderate
Maintenance: Remove any debris and control vegetation growth
Quick Win: N/A

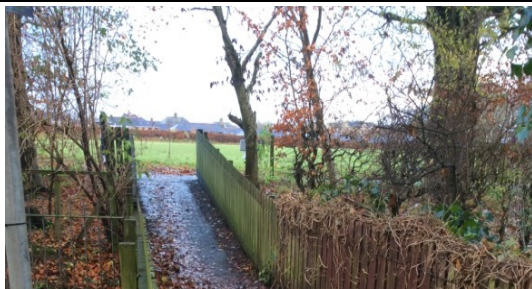
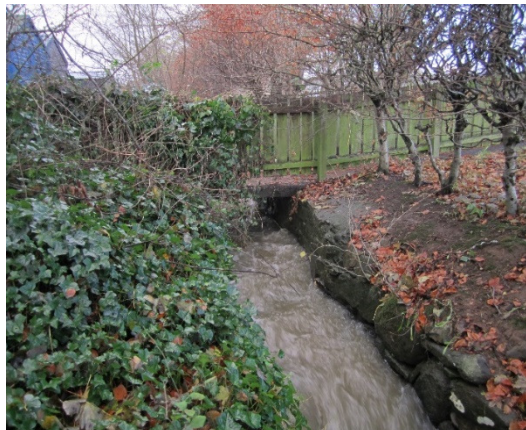
28- Gordon Park footbridge (Refer to Figure 3-3)

View of footbridge

Type: Single-span footbridge
Upstream grid ref: NJ 95081 30356
Length (m): 1.8
Material: Concrete deck / masonry abutments / timber parapet / additional steel angles to parapet
Condition: Grade 3 (Fair)
Part of FPS: Yes
Comments:
 Timber fence showing signs of rot.
 Slight block displacement.
 Possible minor lateral movement at base of abutments.
 Pipe directly upstream of bridge.
Risk of Blockage: High
Maintenance: Keep channel free of debris
Quick Win: N/A

View from upstream

View from downstream

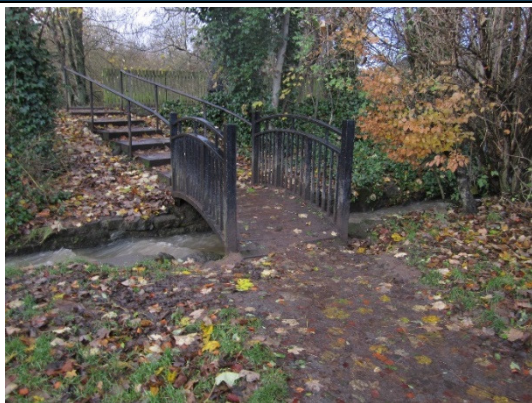
29- Footbridge (Refer to Figure 3-3)

View of footbridge

Condition: Grade 3 (Fair)

Minor corrosion.

Decking worn.

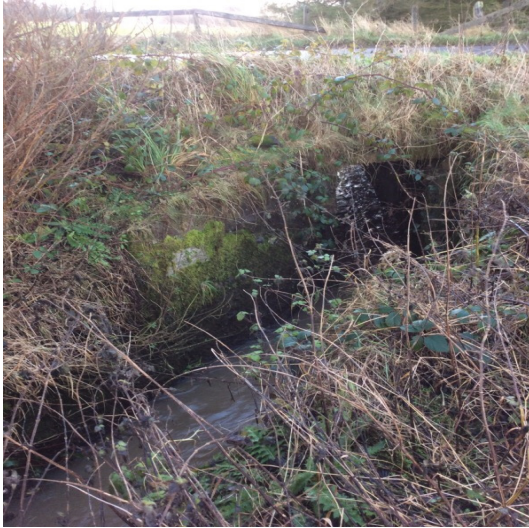
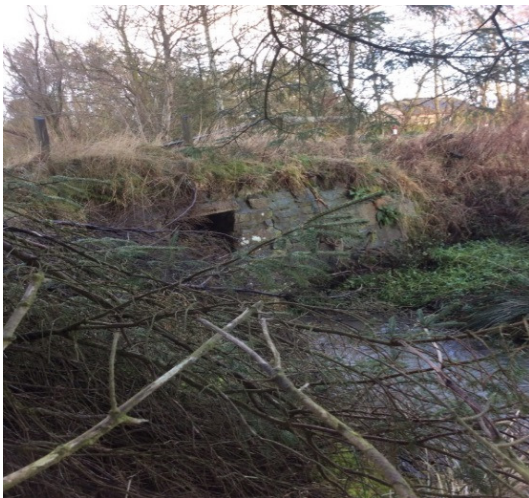
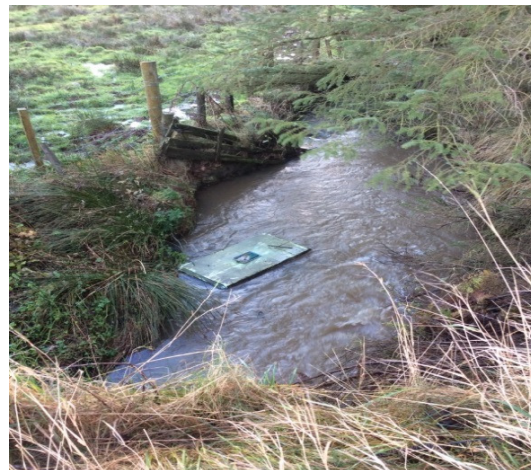
30- Broomfield bridge (Refer to Figure 4-1)

View of culvert from upstream

Type: Masonry slab culvert
Upstream grid ref: NJ 96150 32320

Condition: Grade 3 (Fair)

View of culvert from downstream

Downstream view of watercourse

Maintenance: Keep vegetation growth under control, remove debris

Quick Win: Cut trees around culvert, remove debris and collapsed fence.

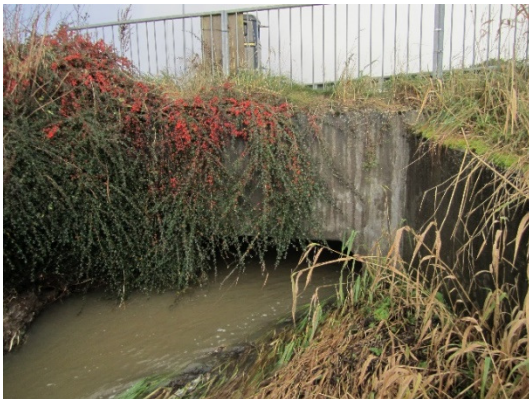
33- Broomies Bridge A948 (Refer to Figure 4-2)

Downstream view of culvert

Type: Box culvert
Upstream grid ref: NJ 96554 31481
Span (m): 2
Rise (m): 0.8
Length (m): 7.3
Material: Reinforced concrete
Condition: Grade 2 (Good)
Part of FPS: No
Comments:
 Minor superficial defects.
 Heavily vegetated banks.
Risk of Blockage: High
Maintenance: Keep growth of vegetation under control, keep free of debris
Quick Win: Remove vegetation around culvert's entrance/exit

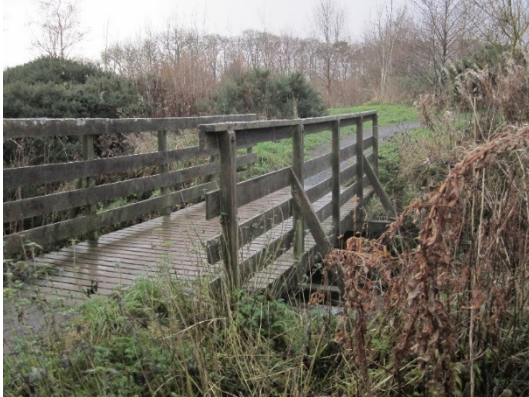
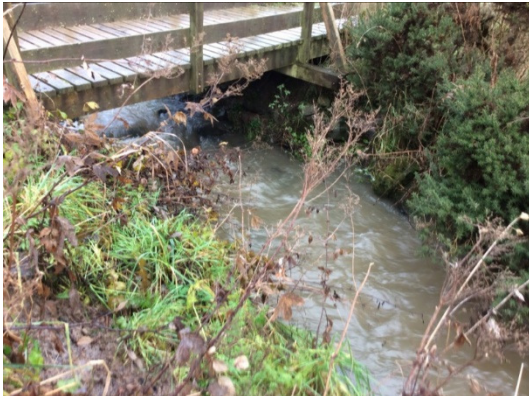
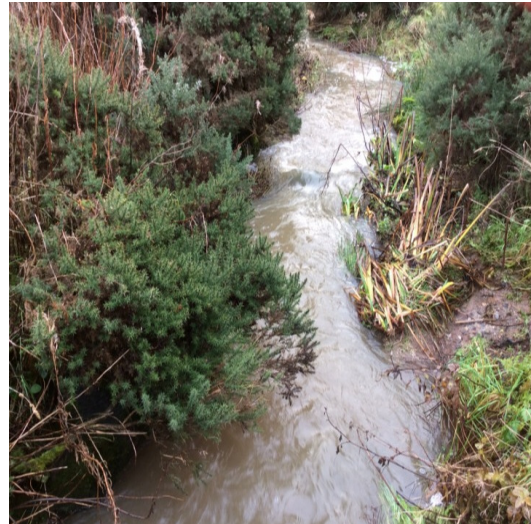
34- Timber bridge (Refer to Figure 4-2)

Upstream view of bridge

Type: Pedestrian bridge
Upstream grid ref: NJ 96621 31227
Span (m): 3
Width (m): 2
Material: Timber
Condition: Grade 3 (Fair)
Part of FPS: No
Comments:
 Minor deformation of beam.
 Rotten and distorted handrails.
 Minor splits of timber decking.
 Fixings present.
Risk of Blockage: Moderate
Maintenance: Keep vegetation growth under control
Quick Win: N/A

View of bridge from upstream

Downstream view of watercourse

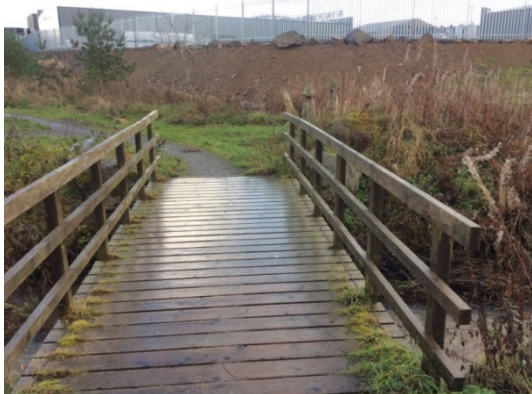
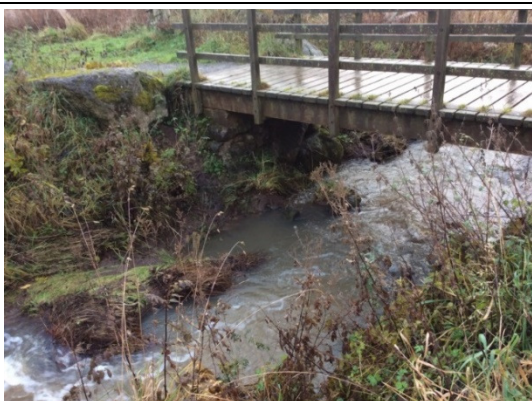
35- Footbridge (Refer to Figure 4-3)

<p>View of bridge</p>	<p>Type: Pedestrian bridge Upstream grid ref: NJ 96666 31155 Span (m): 4 Width (m): 1.9 Height (m): 1.5 (approximately) Material: Timber Condition: Grade 3 (Fair) Part of FPS: No Comments: Erosion at abutments. Slightly distorted and rotten handrails. Minor splits of timber decking. Minor vegetation growth on deck. Exposed loose fixings, washers missing. Risk of Blockage: Moderate Maintenance: Keep vegetation growth under control Quick Win: N/A</p>

<p>Upstream view of bridge</p>

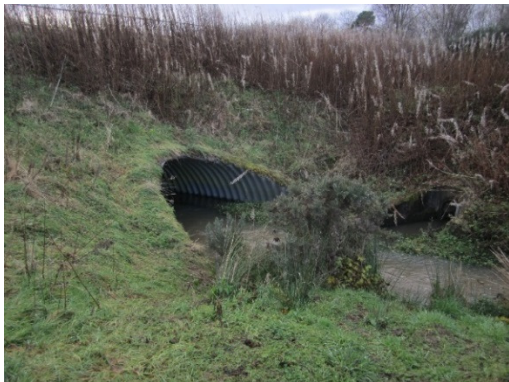
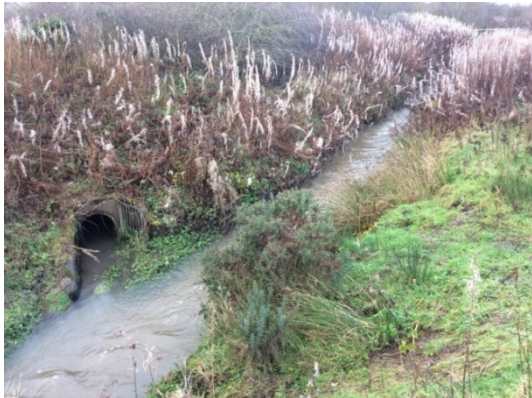
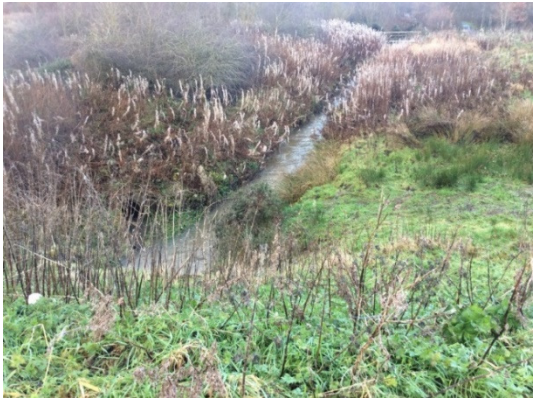
<p>Upstream view of culvert</p>	<p>Type: Semi-circular culvert Upstream grid ref: NJ 96688 31109 Width (m): 3.6 Length (m): 17 approx. Material: Corrugated steel / concrete Condition: Grade 2 (Good) Part of FPS: No Comments: Vegetation growth on top of culvert. Heavily vegetated banks.</p>

36- Culvert (Refer to Figure 4-3)	
	<p>Concrete outlet structure present directly upstream.</p> <p>Risk of Blockage: Moderate</p> <p>Maintenance: Keep watercourse free of debris</p> <p>Quick Win: N/A</p>

<p><i>Concrete outlet structure next to culvert</i></p>

<p><i>Upstream view of watercourse</i></p>

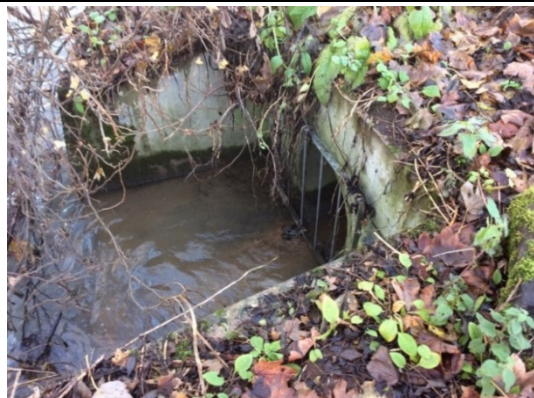
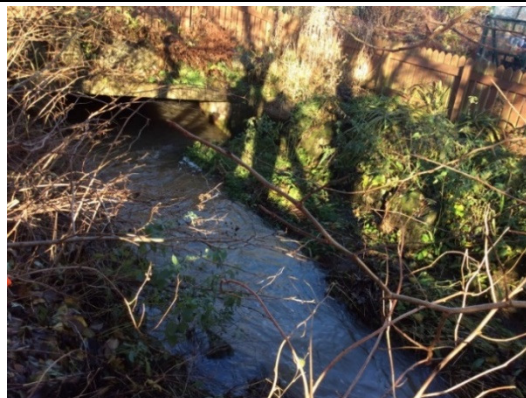
37- Culvert A920 (Refer to Figure 4-3)

<p><i>Upstream view of culvert</i></p>	<p>Type: Simple culvert, hollow concrete slab</p> <p>Upstream grid ref: NJ 96955 30653</p> <p>Inlet span (m): 3.1</p> <p>Outlet span (m): 2.8</p> <p>Rise (m): 0.6</p> <p>Length (m): 33</p> <p>Material: Reinforced concrete slab and abutment</p> <p>Condition: Grade 2 (Good)</p> <p>Part of FPS: No</p> <p>Comments: Minor settlement of soffit. Minor vegetation growth on soffit. Concrete outlet structure directly upstream.</p> <p>Risk of Blockage: High</p> <p>Maintenance: Keep culvert and trash screen free of debris</p> <p>Quick Win: Remove excess vegetation, remove trash screen</p>

Concrete outlet structure

Downstream end of culvert

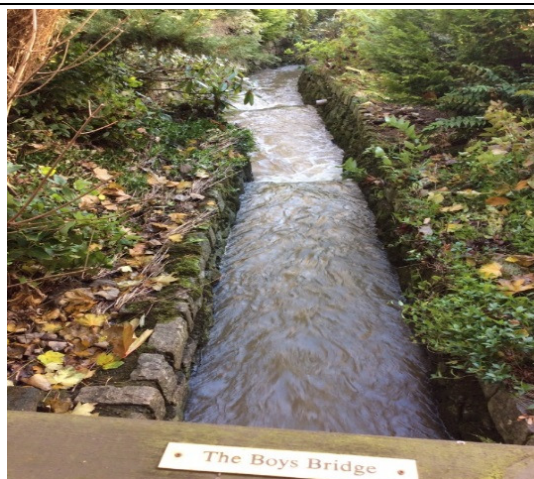
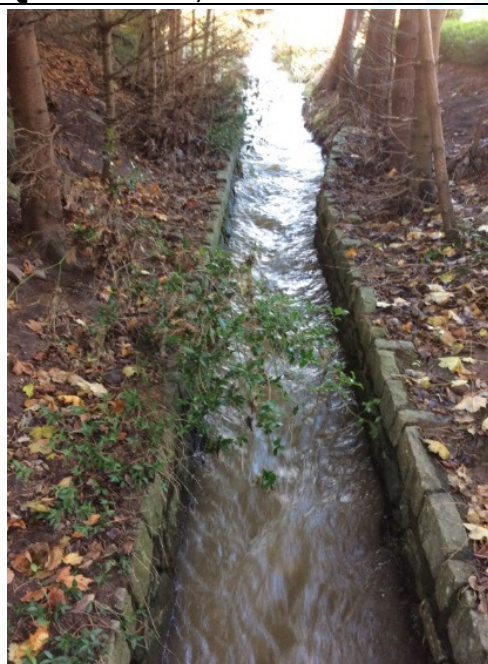
38- Footbridge (Refer to Figure 4-4)

Type: Footbridge
Upstream grid ref: NJ 97085 30578
Width (m): 3.6
Material: Timber / masonry
Condition: Grade 2 (Good)
Part of FPS: No
Comments:
 Superficial defects on handrails.
 Steps in channel downstream.
 Watercourse channelized upstream and downstream.
Risk of Blockage: Low
Maintenance: None required
Quick Win: N/A

Watercourse downstream

Watercourse upstream

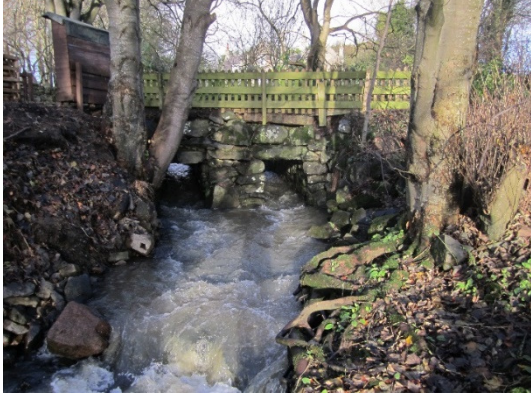
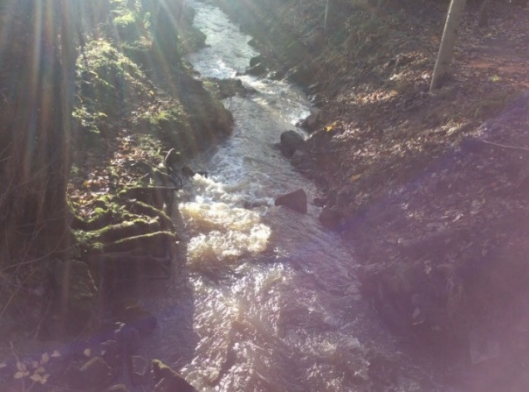
43- Culvert (Refer to Figure 4-4)

<p><i>Upstream view of culvert</i></p>	<p>Type: Twin-bore stone culvert Upstream grid ref: NJ 97148 30505 Material: Stone Condition: Grade 4 (Poor) Part of FPS: No Comments: Possible deformation of shape. Possible displacement of stonework at downstream end. Risk of Blockage: High Maintenance: Keep free of debris Quick Win: N/A</p>

<p><i>Downstream end of culvert</i></p>

<p><i>Downstream view of watercourse</i></p>

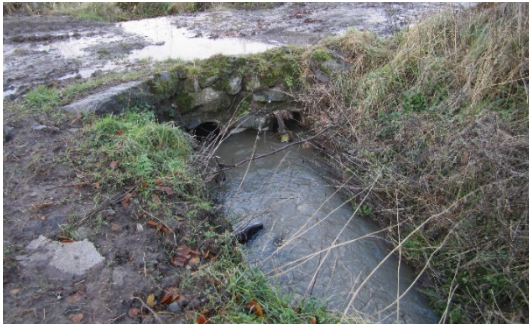
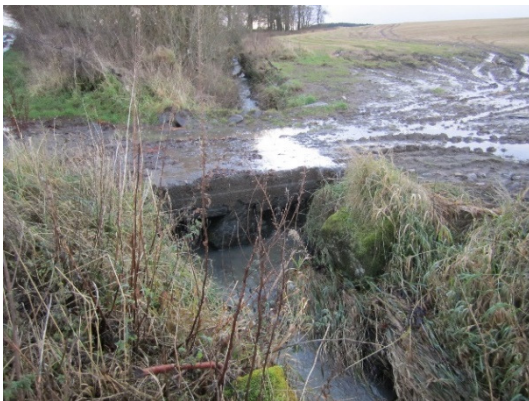
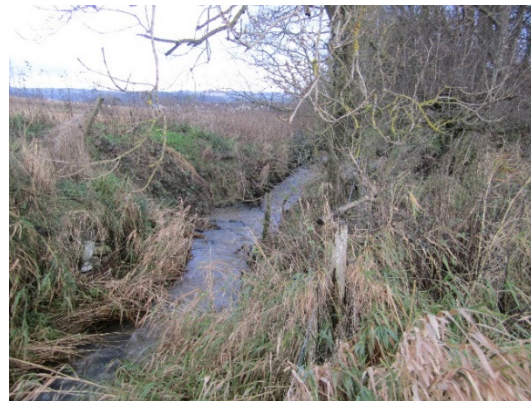
44- Stone culvert (Refer to Figure 5-1)

Culvert upstream

Type: Twin-bore culvert
Upstream grid ref: NJ 94870 29581
Height (m): 0.5
Width of right bore (m): 0.6
Width of left bore (m): 0.5
Diameter (m): 0.45
Pipe Cover (m): 0.6
Material: Stone extended with concrete pipe
Condition: Grade 4 (Poor)
Part of FPS: No
Comments:
 Vegetation growth between stonework.
 Minor deformation of bores.
 Eroded banks upstream and downstream.
 No trash screen.
 Neighbour complaining that culvert causes flooding (possible collapse).
Risk of Blockage: High
Maintenance: Keep free of debris
Quick Win: N/A

Culvert downstream

Downstream view of watercourse

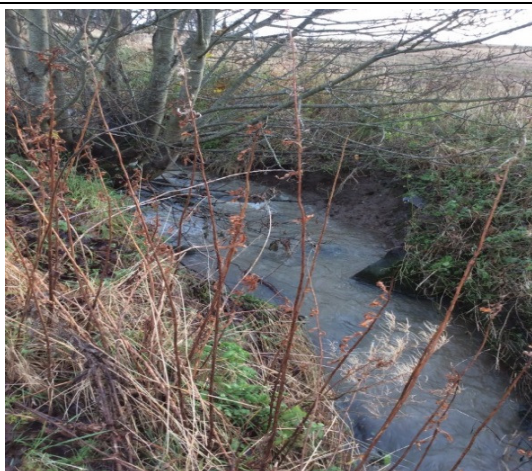
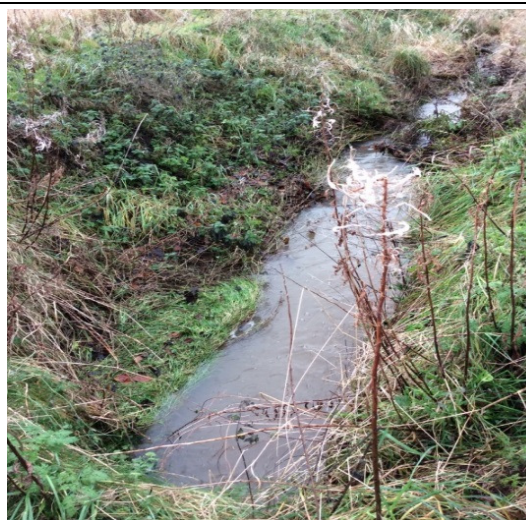
45- Stone culvert (Refer to Figure 5-1)

Type: Simple culvert
Upstream grid ref: NJ 94802 29695
Width (m): Unknown
Material: Stone
Condition: Grade 3 (Fair)
Part of FPS: No
Comments: Vegetation blocking part of culvert. Distortion of cross section.
Risk of Blockage: High
Maintenance: Keep vegetation growth under control
Quick Win: N/A

Upstream view

Downstream view

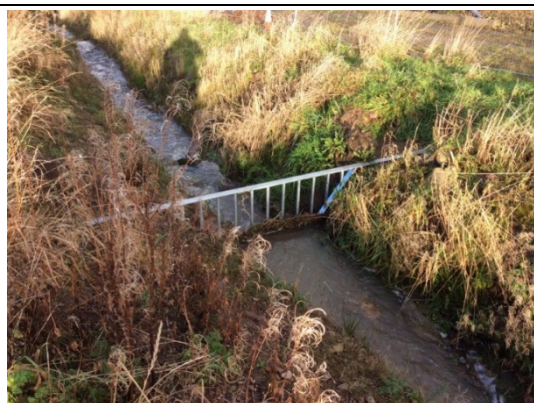
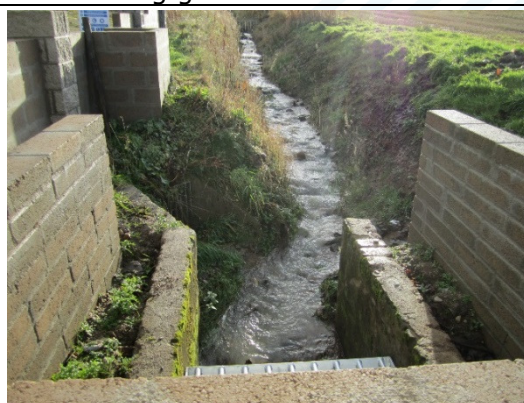
47- Hillhead Drive culvert (Refer to Figure 6-1)

Type: Culvert headwall and screen
Upstream grid ref: NJ 95343 29732
Headwall Height (m): 2.1
Headwall Width (m): 2.31
Material: Concrete / masonry
Condition: Grade 3 (Fair)
Part of FPS: Yes
Comments:
 Vertical cracks at corners of old headwall.
 Minor vegetation growth on concrete headwalls.
 Loss of mortar at masonry headwall.
 Moderately steep and eroded banks.
 High flows bypass the culvert.
 Poor access to clean trash screen.
 Not tied in to surrounding ground.
Risk of Blockage: Moderate
Maintenance: Keep trash screens free of debris
Quick Win: Tie in head wall to surrounding ground

Trash screen upstream of culvert

Upstream view of watercourse

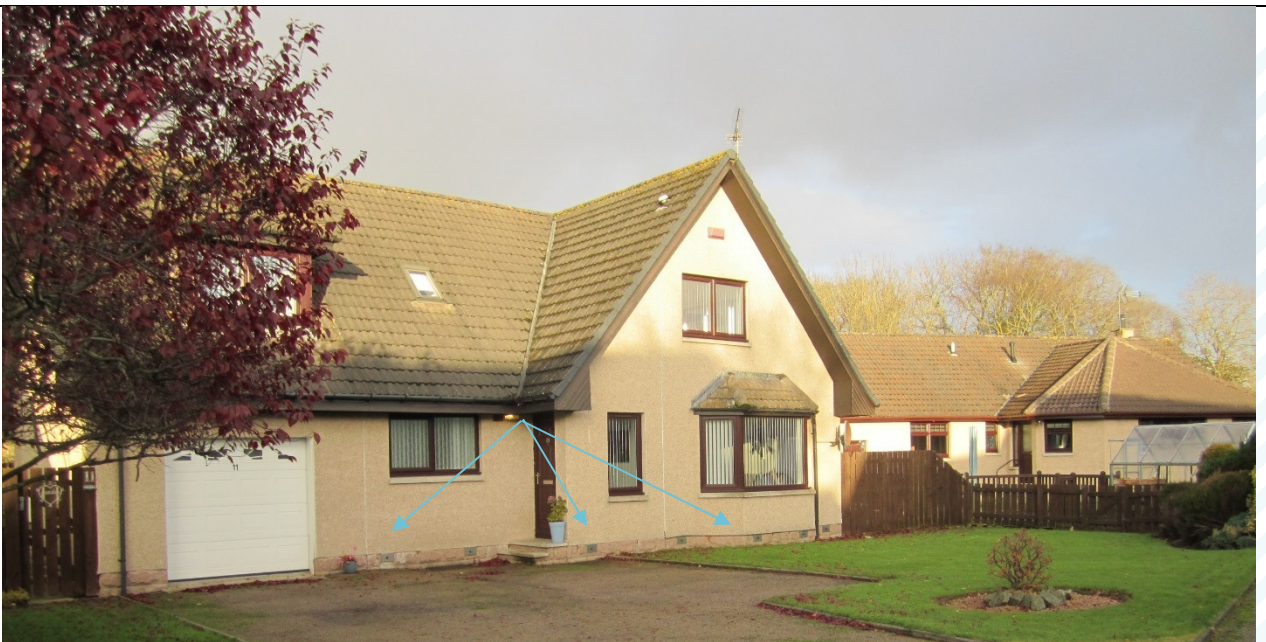
Figure 7-7: Property Level Protection of 11 The Meadows

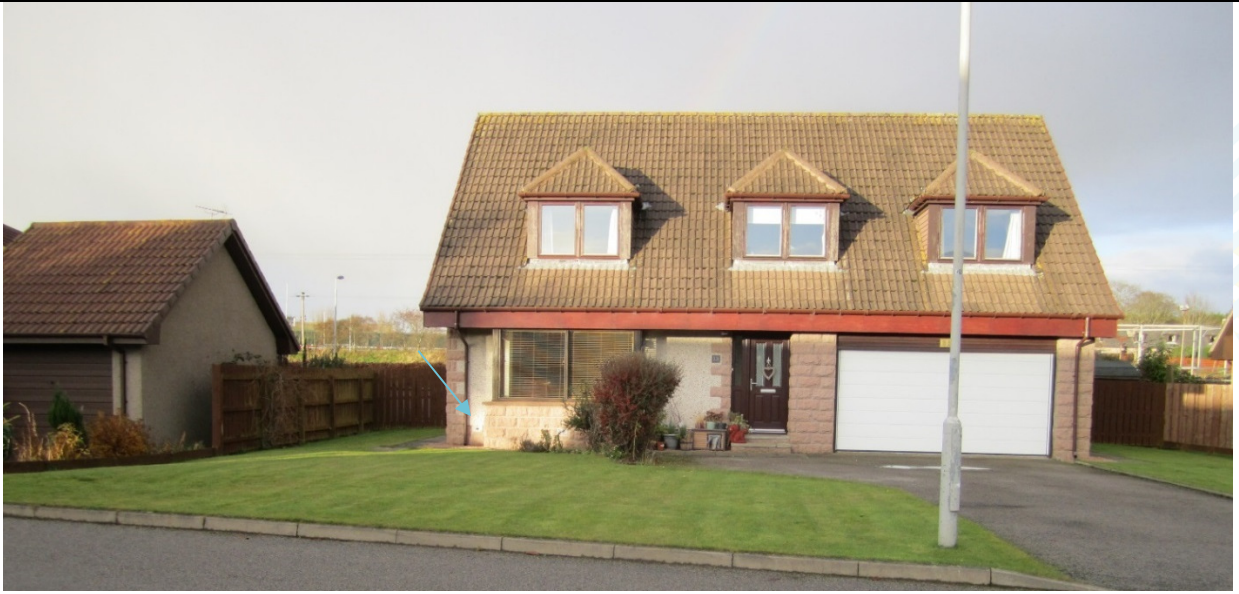
Figure 7-8: Property Level Protection of 13 The Meadows
